Regal® Flushometer

The repair kits and parts listed on this page are designed to service all Sloan diaphragm type Flushometers, including those manufactured for low consumption (LC) usage.

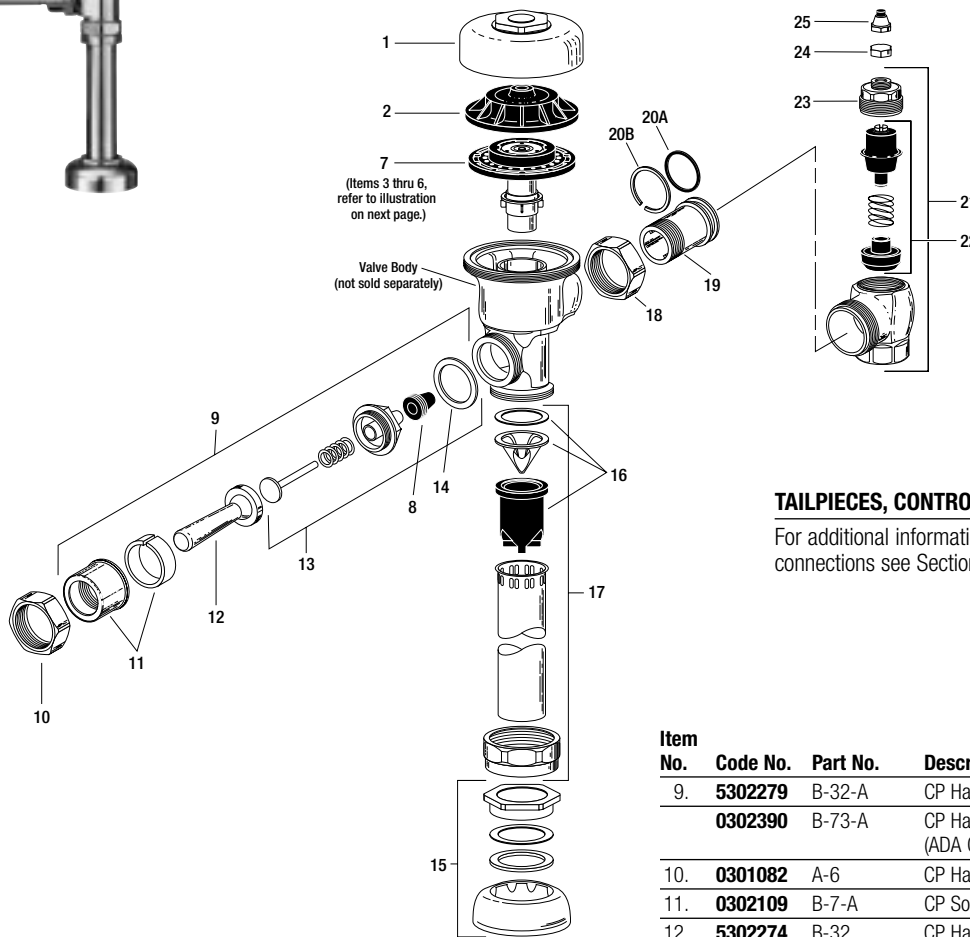
Item No.	Code No.	Part No.	Description
1.	0317004	R-10	CP Cover
2.	0301168	A-71	Inside Cover
SEE ITEMS 3A THROUGH 6E IN CHART ON NEXT PAGE			
3A.	5301058	A-19-AC	Relief Valve, White (Closet) – 12 per package
3B.	5301059	A-19-AU	Relief Valve, Black (Urinal) – 12 per package
3C.	5301211	A-19-ALC	Relief Valve, Green (Closet/Urinal-LC) – 12 per package
3D.	0301143	A-19-AL	Relief Valve, Blue (9 Liter Closet) – 12 per package

4.	5301111	A-15-A	Disc – for all Inside Parts Kits – 12 per package
5.	5301188	A-156-A	Diaphragm – for all Inside Parts Kits – 12 per package
6A.	5301236	A-163-A	Guide Assembly 4.5 gpf/17.0 Lpf Closet & 1.5 gpf/5.7 Lpf Urinal – 12 per package
6B.	5301032	A-152-A	Guide Assembly 3.5 gpf/13.2 Lpf Closet – 12 per package
6C.	5301031	A-151-A	Guide Assembly 1.6 gpf/6.0 Lpf LC Closet – 12 per package
6D.	5301155	A-155-A	Guide Assembly 1.0 gpf/3.8 Lpf LC Urinal – 12 per package
6E.	5301157	A-157-A	Guide Assembly 0.5 gpf/1.9 Lpf Urinal – 12 per package

7.	SEE INSIDE PARTS KITS CHART ON NEXT PAGE		
8.	5302297	B-39	Seal – 12 per package

Item No.	Code No.	Part No.	Description
9.	5302279	B-32-A	CP Handle Assembly – 6 per package
	0302390	B-73-A	CP Handicap Handle Assembly (ADA Compliant)
10.	0301082	A-6	CP Handle Coupling

11.	0302109	B-7-A	CP Socket Assembly
12.	5302274	B-32	CP Handle Grip – 12 per package
	0302389	B-74-A	CP Handicap Handle Grip (ADA Compliant)
13.	5302305	B-50-A	Handle Repair Kit – 6 per package

14.	5301139	A-31	Handle Gasket – 48 per package
15.	0306102	F-54-A	3/4" CP Spud Coupling Assembly
	0306142	F-55-A	1-1/4" CP Spud Coupling Assembly
	0306145	F-56-A	1-1/2" CP Spud Coupling Assembly

16.	3323192	V-551-A	Vacuum Breaker Repair Kit
17.	5323005	V-500-AA	3/4" x 9" CP Vacuum Breaker – 6 per package
	5323006	V-500-AA	1-1/4" x 9" CP Vacuum Breaker – 6 per package
	5323007	V-500-AA	1-1/2" x 9" CP Vacuum Breaker – 6 per package

18.	0308676	H-550	CP Stop Coupling
19.	0308801	H-551-A	CP Adjustable Tailpiece 2-1/16" long
20A.	5308696	H-553	O-ring – 24 per package
20B.	5308381	H-552	Locking ring – 12 per package

21.	0388029	H-740-A	1" Screwdriver Bak Chek® Stop CP – complete
	0388031	H-740-A	3/4" Screwdriver Bak Chek® Stop CP – complete
22.	3308853	H-541-ASD	1" Control Stop Repair Kit *
	3308856	H-543-ASD	3/4" Control Stop Repair Kit **

23.	0308991	H-639	CP Bonnet *
	0308601	H-538	CP Bonnet **
24.	5308156	H-37	CP Cap – 6 per package
25.	5310034	J-2/J-7	Bumper Assembly – 6 per package

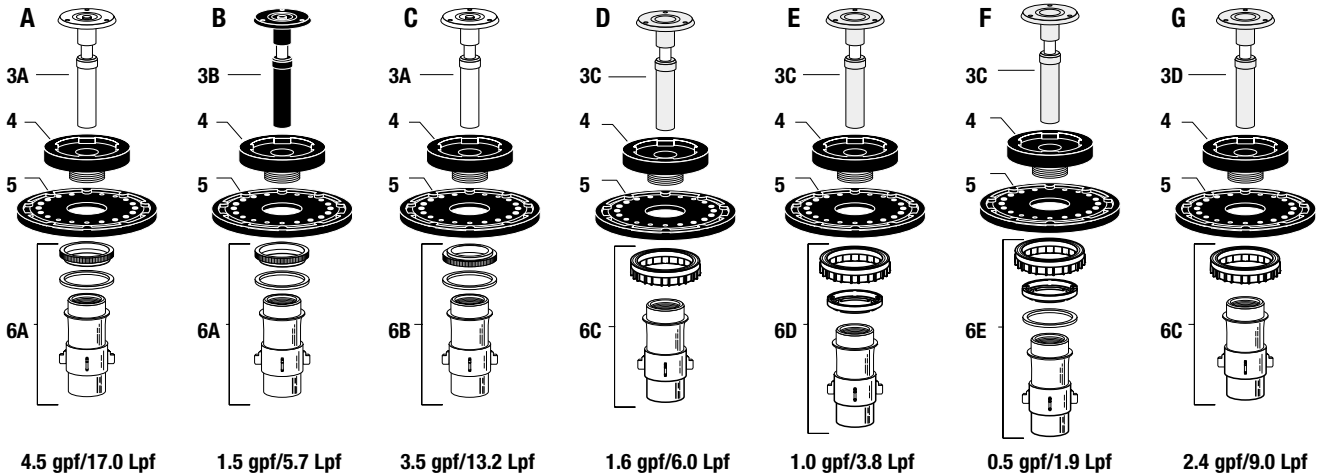
ITEM 7. INSIDE PARTS COMPONENTS

ITEM 7. INSIDE PARTS KITS (SEE ILLUSTRATION ON PREVIOUS PAGE)

Item No.	Code No.	Part No.	Application
A.	3301036	A-36-A	4.5 gpf/17.0 Lpf - Closet
B.	3301037	A-37-A	1.5 gpf/5.7 Lpf - Urinal
C.	3301038	A-38-A	3.5 gpf/13.2 Lpf - Closet
D.	3301041	A-41-A	1.6 gpf/6.0 Lpf - Closet
E.	3301044	A-42-A	1.0 gpf/3.8 Lpf - Urinal
F.	3301081	A-43-A	0.5 gpf/1.9 Lpf - Urinal
G.	3301024	A-44-A	2.4 gpf/9.0 Lpf - Closet

Item No.	Code No.	Part No.	Description
3A.	5301058	A-19-AC	Relief Valve, White (Closet) – 12 per package
3B.	5301059	A-19-AU	Relief Valve, Black (Urinal) – 12 per package
3C.	5301211	A-19-ALC	Relief Valve, Green (Closet/Urinal-LC) – 12 per package
3D.	0301143	A-19-AL	Relief Valve, Blue (9 Liter Closet) – 12 per package
4.	5301111	A-15-A	Disc – for all Inside Parts Kits – 12 per package
5.	5301188	A-156-A	Diaphragm – for all Inside Parts Kits – 12 per package
6A.	5301236	A-163-A	Guide Assembly 4.5 gpf/17.0 Lpf Closet & 1.5 gpf/5.7 Lpf Urinal – 12 per package
6B.	5301032	A-152-A	Guide Assembly 3.5 gpf/13.2 Lpf Closet – 12 per package
6C.	5301031	A-151-A	Guide Assembly 1.6 gpf/6.0 Lpf LC Closet – 12 per package
6D.	5301155	A-155-A	Guide Assembly 1.0 gpf/3.8 Lpf LC Urinal – 12 per package
6E.	5301157	A-157-A	Guide Assembly 0.5 gpf/1.9 Lpf Urinal – 12 per package
